Canon ImageCLASS MF4350d Scanner light Replacement

This guide will allow you to replace your scanner's light.

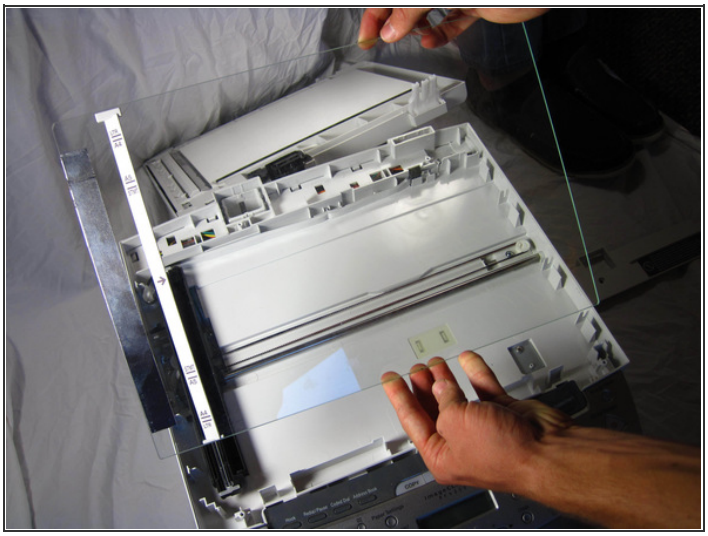
Step 5

- After you have taken off the plate, check to make sure that there is no broken glass. If there is broken glass handle it with gloves. Broken glass, if handled improperly, can cause physical injury.
